TOWN OF INDIAN TRAIL, NC ADA TRANSITION PLAN

TOWN OF INDIAN TRAIL, NC RIGHT-OF-WAY SELF-ASSESSMENT

TOWN OF INDIAN TRAIL, NC FACILITY ASSESSMENT

TOWN OF INDIAN TRAIL, NC PARKS ASSESSMENT

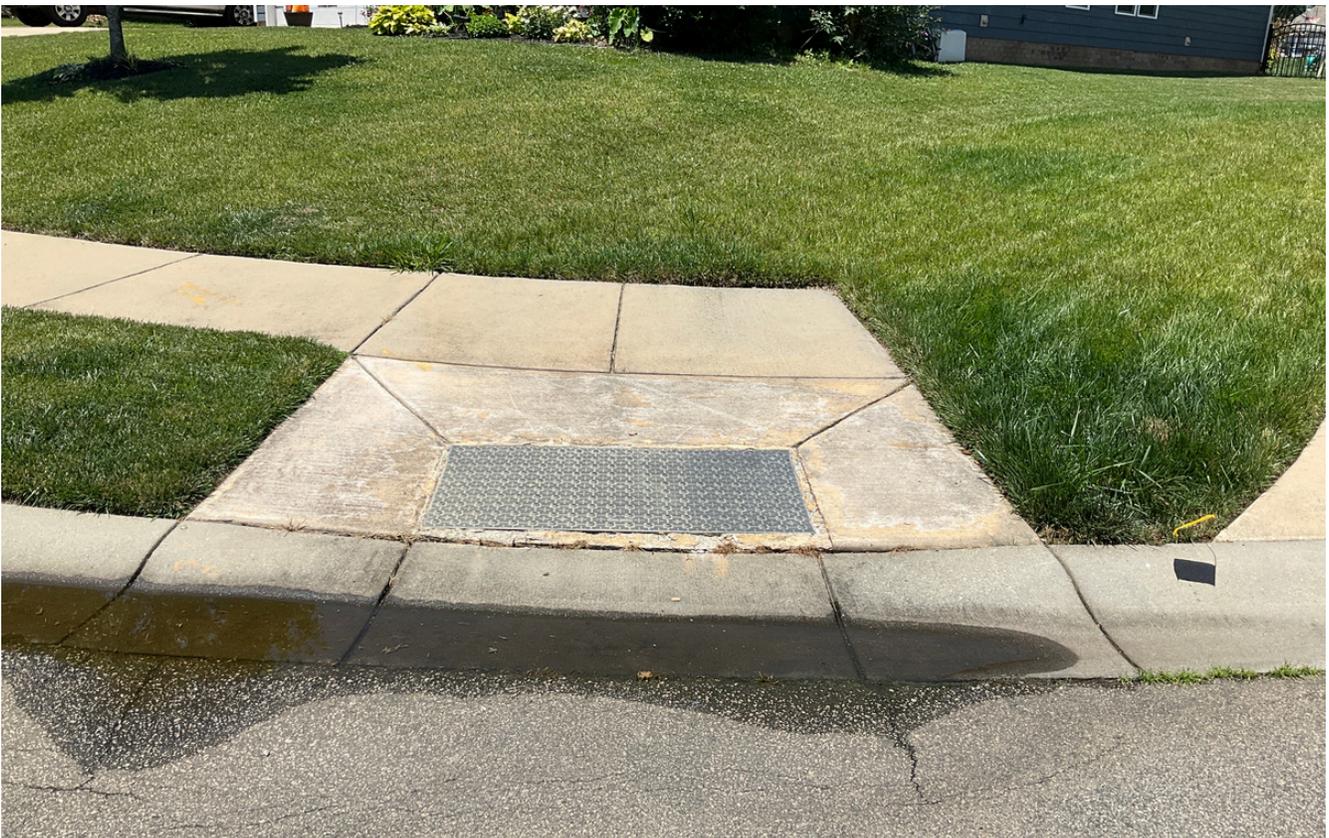
Water ponding at the bottom of curb ramps can create significant ADA barriers in the pedestrian access route, especially for those using wheelchairs. This accumulation of water can lead to slippery surfaces, increasing the risk of falls and injuries. For wheelchair users, water ponding presents a barrier that can make it difficult or even impossible to navigate the ramp. The wheels of a wheelchair can get stuck in the water, causing delays or forcing users to find alternative routes in the traffic lane, creating hazardous pedestrian experiences. Additionally, standing water can cause structural damage over time, leading to uneven surfaces that further impede accessibility. Such conditions are ADA barriers and pose safety hazards, reducing the overall usability of pedestrian pathways for everyone.

Caption: Curb ramp with ponding.

Remediation for ponding can cost between \$2,500 and \$15,000, depending on the severity of the ponding issue and whether alternative maintenance activity options are available.

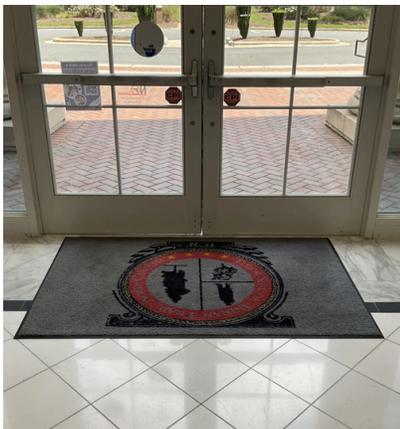
ACCESSIBLE ROUTE

The carpet, rug, or mat is not secured in place.

Recommendation: Install nonslip backing or replace

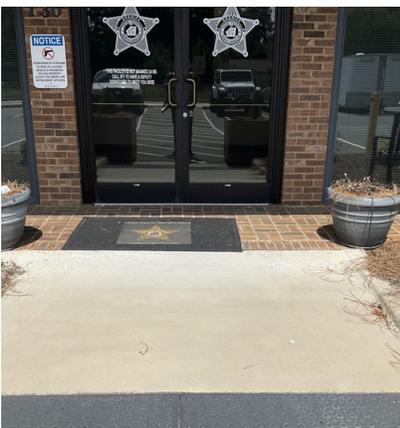
CURB RAMP

The landing of the ramp has a slope greater than 2 percent.

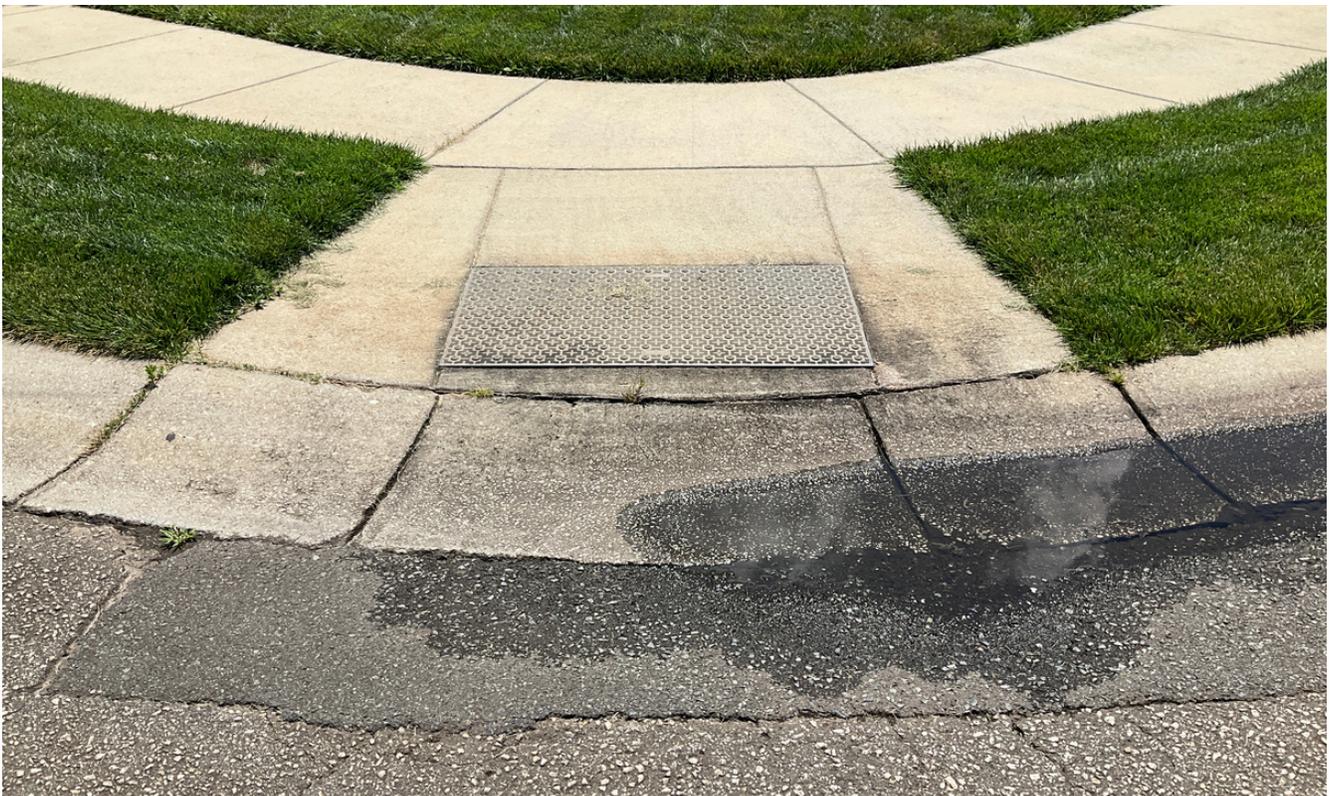
Caption: Example of ponding in the accessible route.

Remediation for ponding can cost between \$2,500 and \$15,000 depending on the severity of the ponding issue and whether alternative maintenance activity options are available.

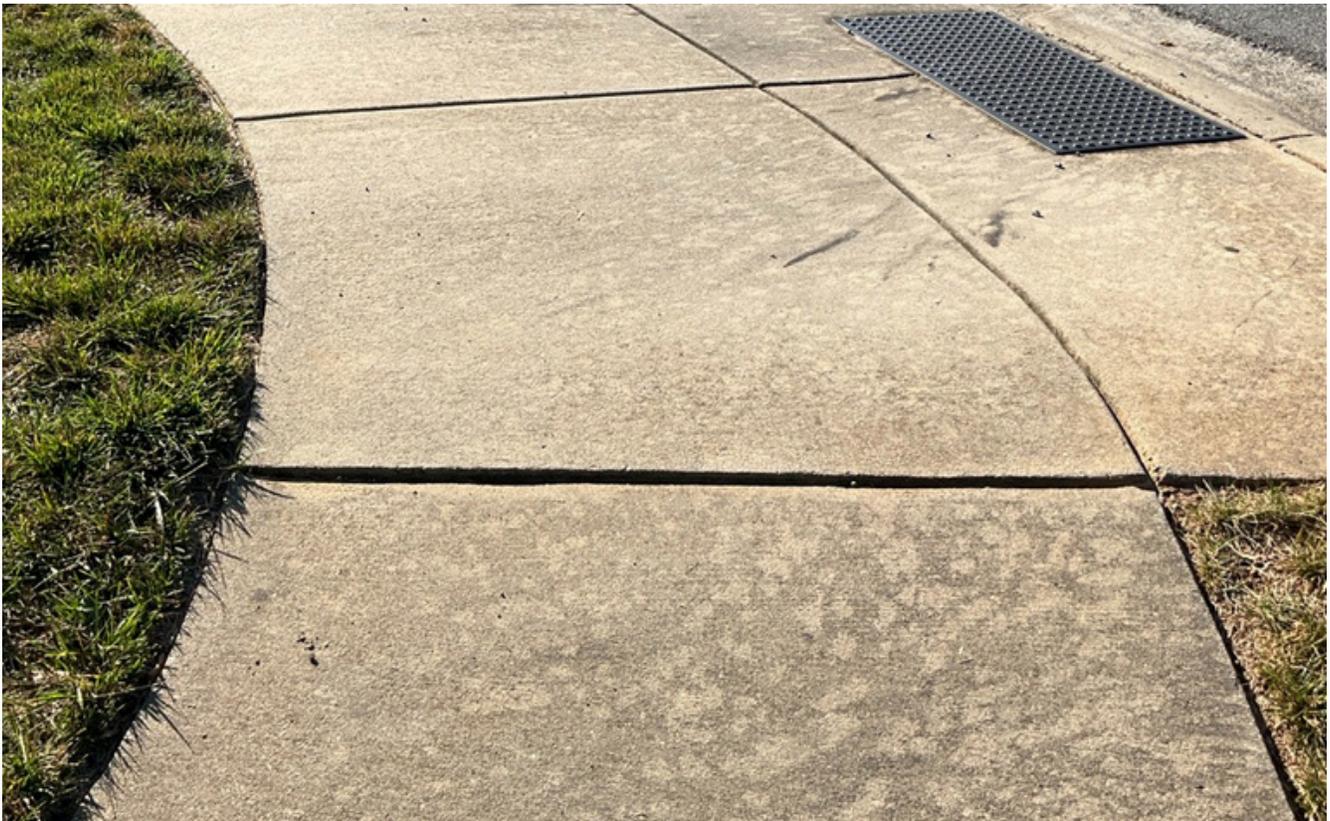
Noting individual vertical height displacement locations was not within the scope of this assessment. However, based on historical data, VHDs are the No.1 barrier class on accessible routes

Caption: Example of Vertical Height Displacement.

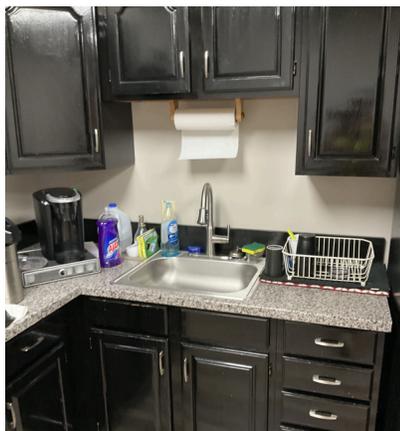
ACCESSORIES

The paper towel dispenser's operation mechanism is too high off the floor.

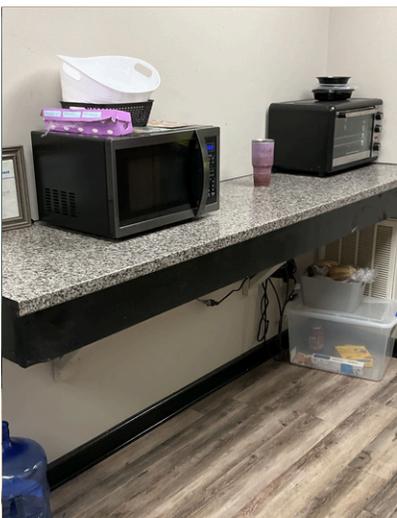
COUNTER TOP

The kitchen counter top is too high.

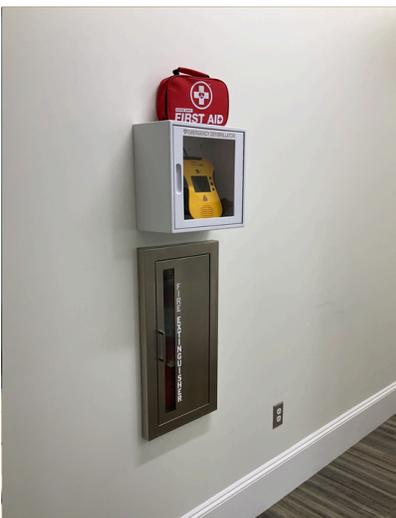
REACH RANGE

The (AED cabinet) is positioned too high for either a side or front approach.

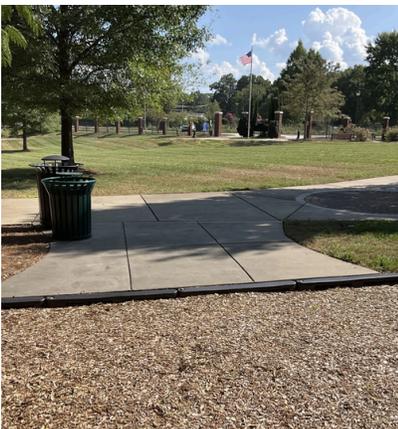
ACCESSIBLE ROUTE

There is no accessible route to the accessible element.

Recommendation: Install compliant transition ramp

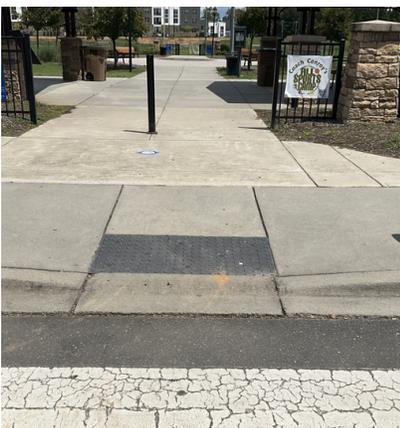
CURB RAMP

The change in level where the gutter meets the curb ramp is greater than 1/4 inch.

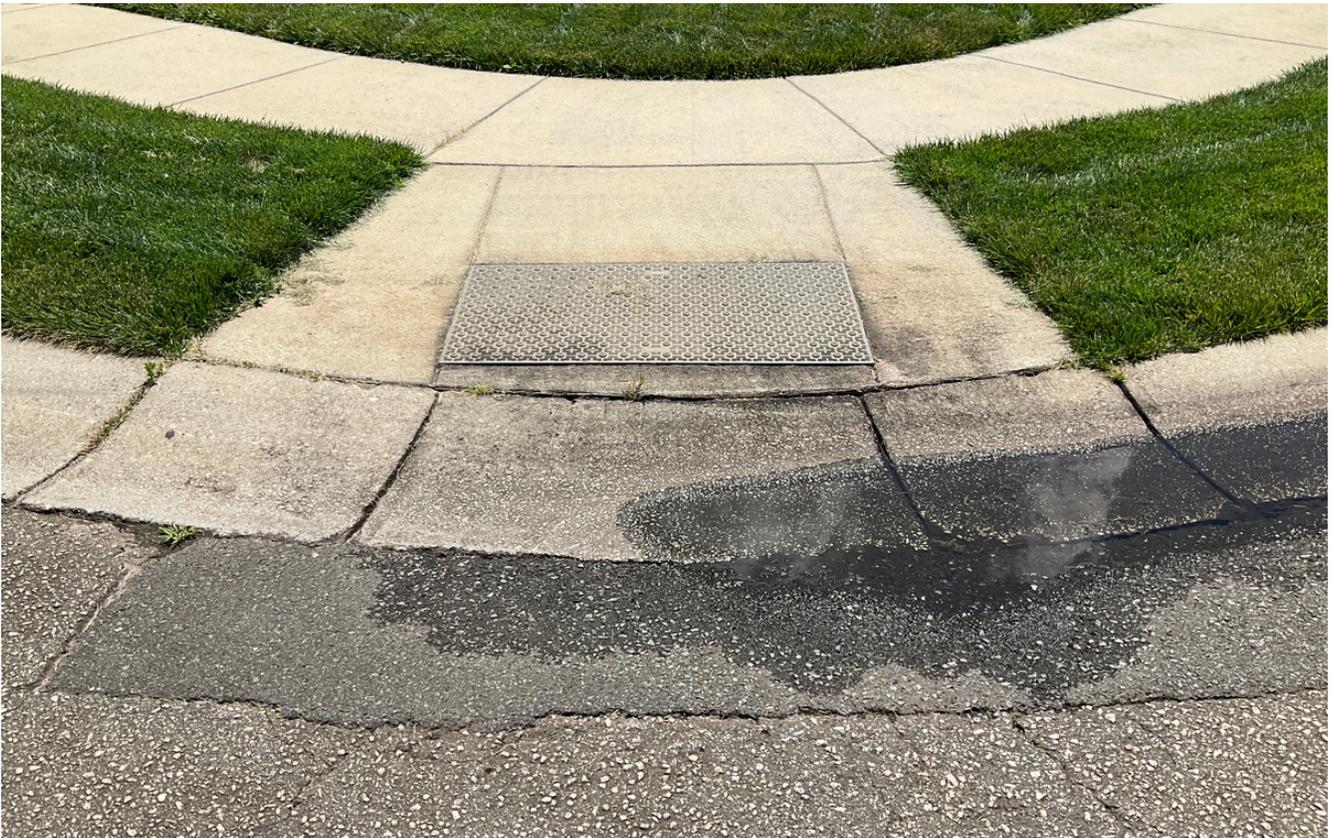
Caption: Example of ponding in the accessible route.

Remediation for ponding can cost between \$2,500 and \$15,000 depending on the severity of the ponding issue and whether alternative maintenance activity options are available.

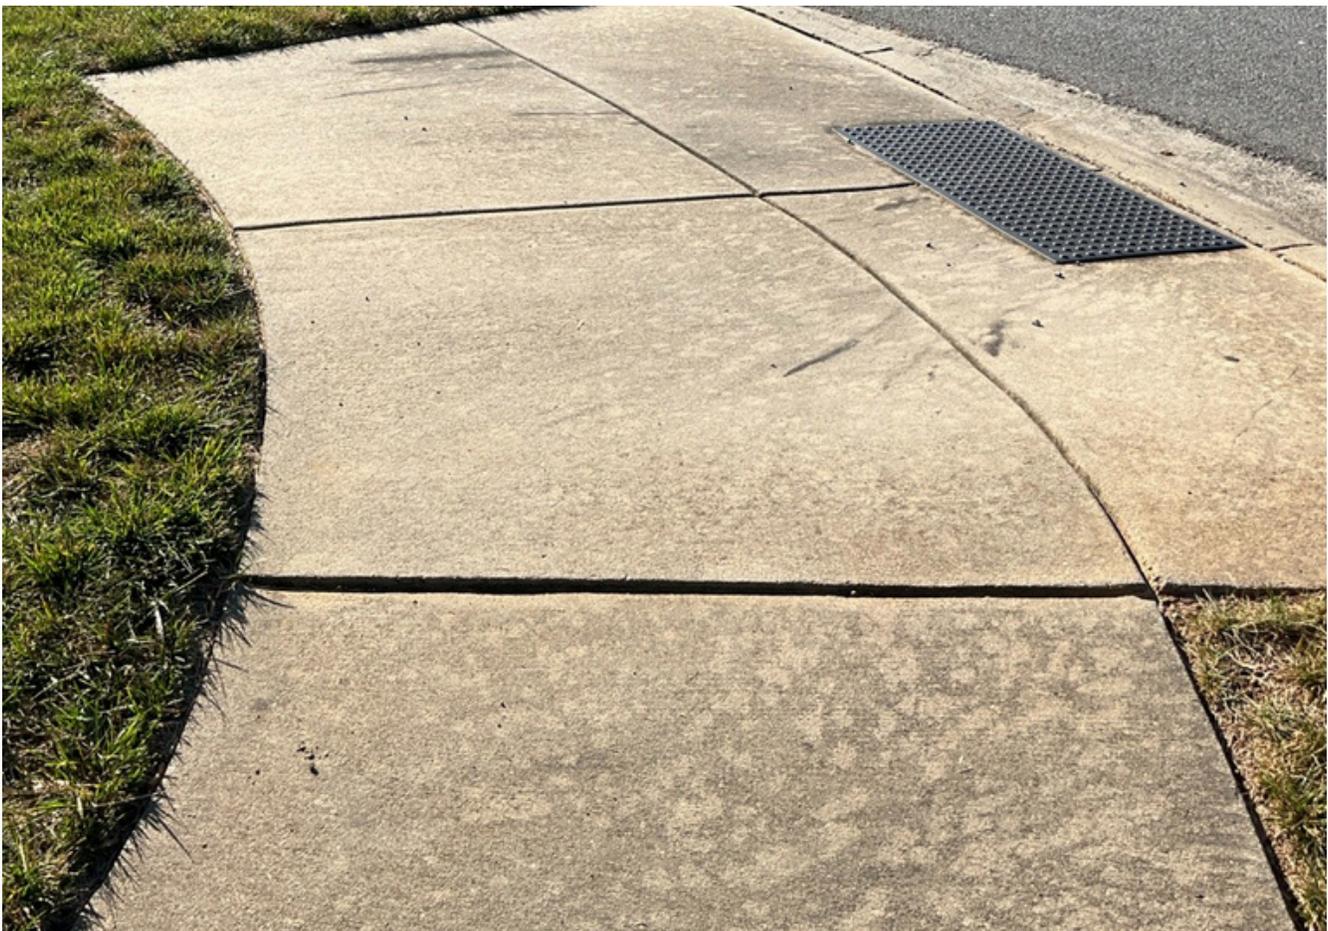
Caption: Example of VHDs in the accessible route.

Demolition & Replacement cost will be approximately \$15 per square foot of panel replaced, if used instead of the alternative maintenance activity.

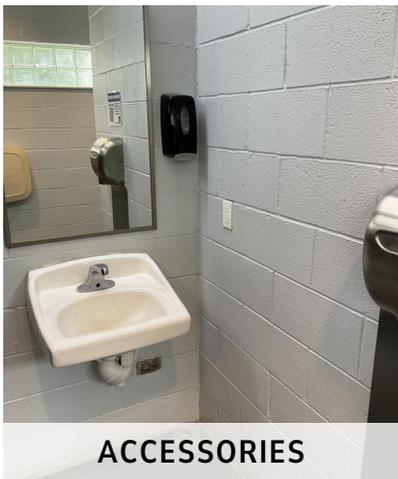
The dispenser's operable part is not within reach range above the floor.

Dispensers must have all operable parts a maximum of 48 inches above the floor.

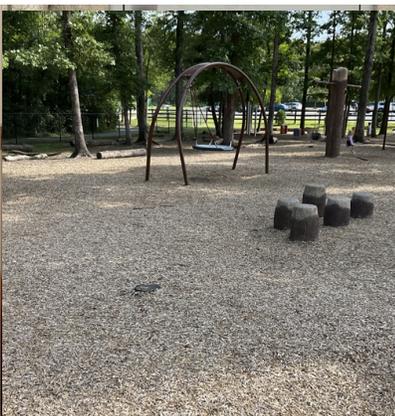
SURFACE

Compliance with ASTM F1951 for accessibility for ground surfaces on accessible routes, clear floor or ground spaces, and turning spaces has not been determined.

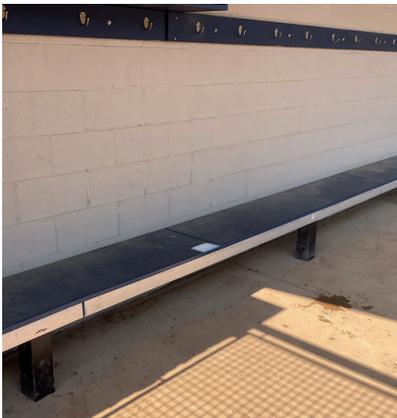
SEATING

An accessible wheelchair space is not provided in the team/player seating area.
