TOWN OF INDIAN TRAIL, NC ADA TRANSITION PLAN

TOWN OF INDIAN TRAIL, NC RIGHT-OF-WAY SELF-ASSESSMENT

TOWN OF INDIAN TRAIL, NC FACILITY ASSESSMENT

TOWN OF INDIAN TRAIL, NC PARKS ASSESSMENT

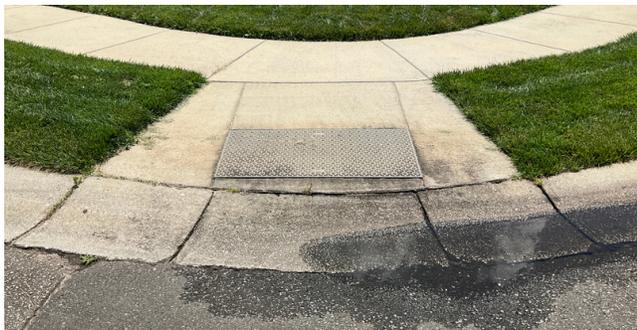
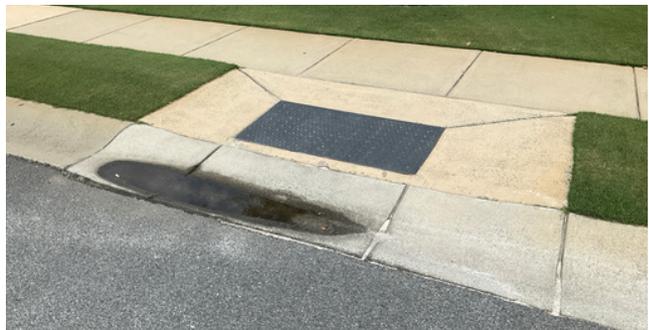
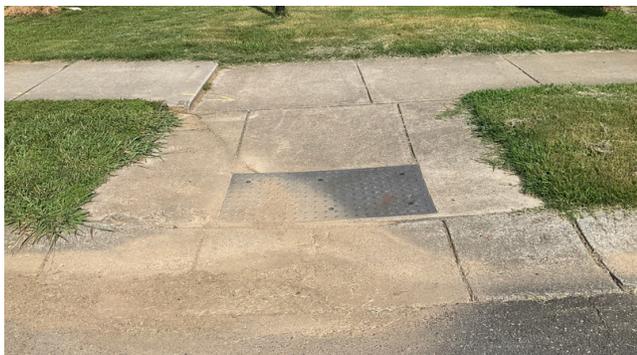
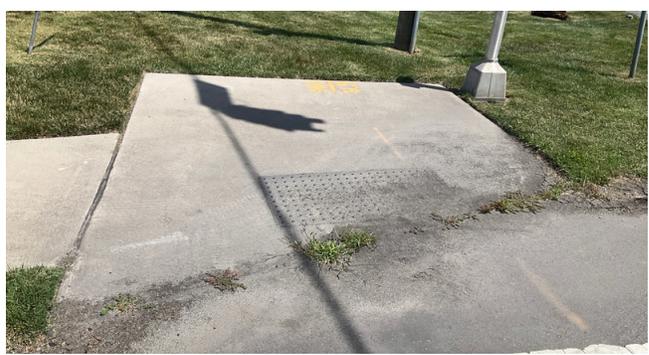
Locations & Examples of Ponding

Water ponding at the bottom of curb ramps can create significant ADA barriers in the pedestrian access route, especially for those using wheelchairs. This accumulation of water can lead to slippery surfaces, increasing the risk of falls and injuries. For wheelchair users, water ponding presents a barrier that can make it difficult or even impossible to navigate the ramp. The wheels of a wheelchair can get stuck in the water, causing delays or forcing users to find alternative routes in the traffic lane, creating hazardous pedestrian experiences. Additionally, standing water can cause structural damage over time, leading to uneven surfaces that further impede accessibility. Such conditions are ADA barriers and pose safety hazards, reducing the overall usability of pedestrian pathways for everyone.

Ponding locations also create sediment build-up and degradation of the accessible route.

Caption: Curb ramp with ponding.

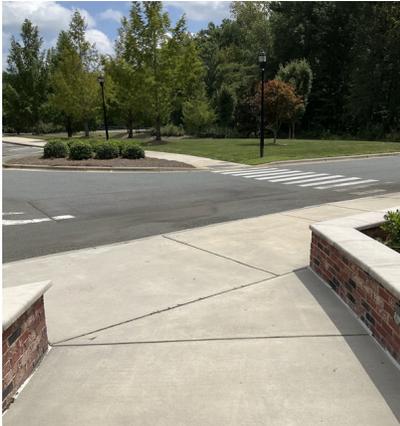
ACCESSIBLE ROUTE

The accessible path of travel between the building entrance and the accessible parking has cross slopes greater than 2%.

Recommendation: Re-pour to compliant walkway. capital investment

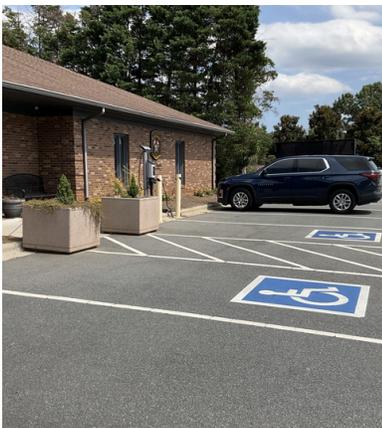
PARKING LOT

The running slope (long dimension) of the accessible parking stall exceeds 2%.

Recommendation: Level, repave and repaint

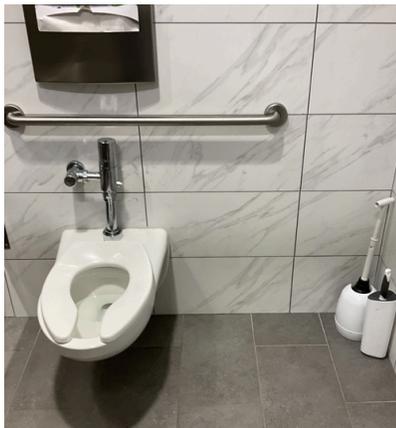
TOILET

The clear floor space around the toilet is obstructed by the (cleaning supplies).

Recommendation: Remove cleaning supplies

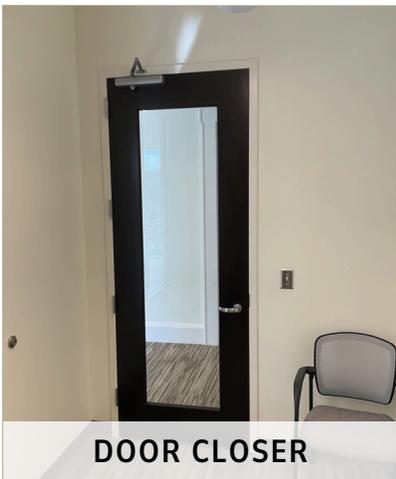
DOOR CLOSER

The door is equipped with a door closer and returns to a closed position too quickly.

Recommendation: Adjust or replace door closer.

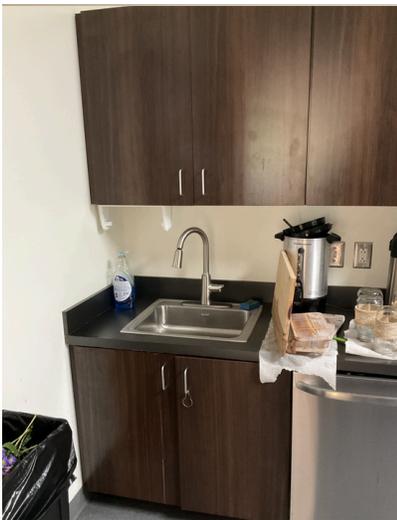
SINKS

Knee and toe clearance has not been provided at the sink.

Recommendation: Provide sink with compliant knee and toe clearance. capital investment

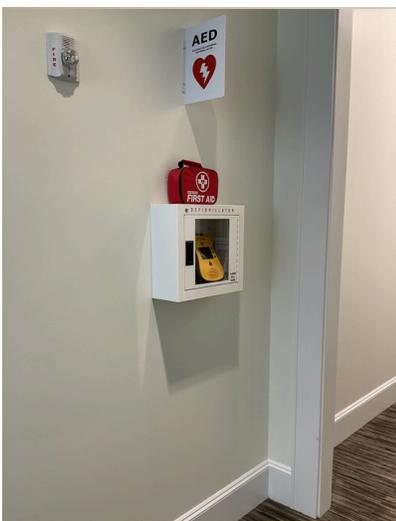
REACH RANGE

The (AED cabinet) is positioned too high for either a side or front approach.

Recommendation: Relocate to compliant height

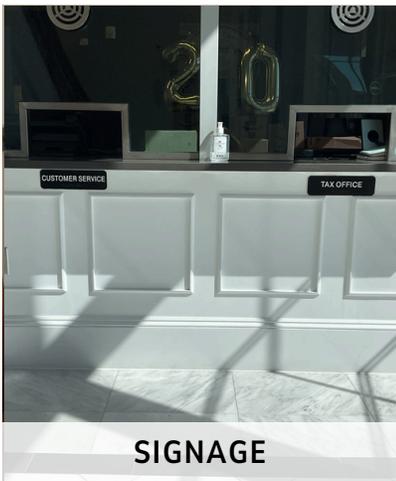
The wall sign is mounted too low.

Tactile Characters on signs shall be located 48 inches minimum above the finish floor or ground surface, measured from the baseline of the lowest tactile character and 60 inches maximum above the finish floor or ground surface, measured from the baseline of the highest tactile character.

Recommendation: Replace or relocate to compliant height

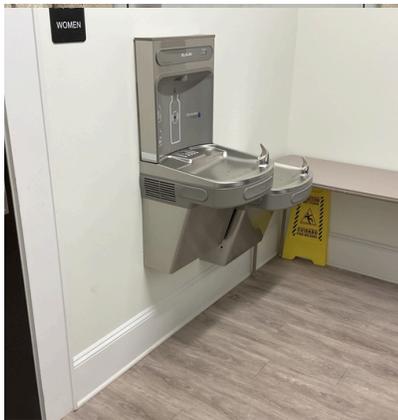
DRINKING FOUNTAIN

The drinking fountain projects from the wall into the pedestrian way with its leading edge above 27 inches from the floor.

Recommendation: Reconfigure fountain height or provide cane detection

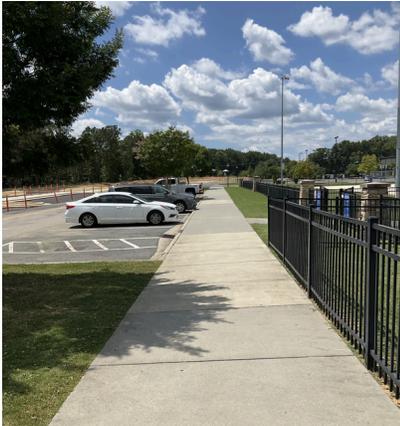
ACCESSIBLE ROUTE

The accessible route of travel on the walk or sidewalk has cross slopes greater than 2%.

Recommendation: Level and replace affected panels (>100 ft). Capital investment

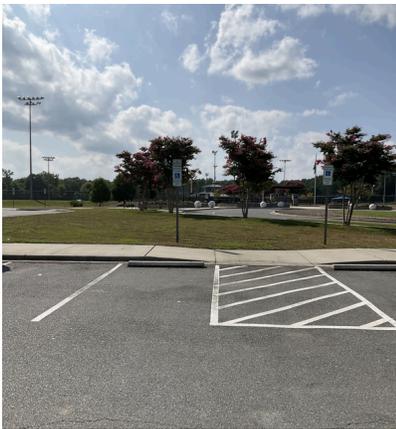
ACCESS AISLE

The running slope (long dimension) of the accessible parking stall exceeds 2%.

Recommendation: Level, repave and repaint 9 spaces

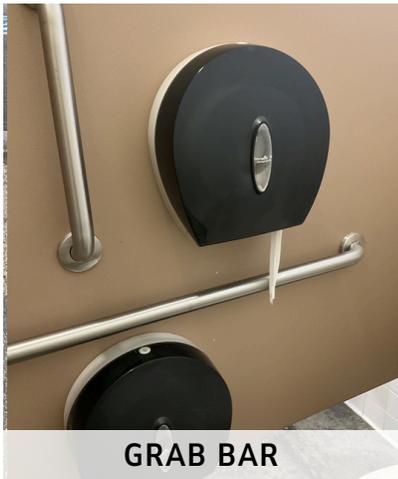
The toilet paper dispenser is mounted too close to the top of the grab bar, minimizing the gripping surface.

Adjacent elements shall be positioned to provide unobstructed use of grab bars. The space between the grab bar and projecting objects above shall be 12 inches minimum.

Recommendation: Relocate upper dispensers clear of grab bar

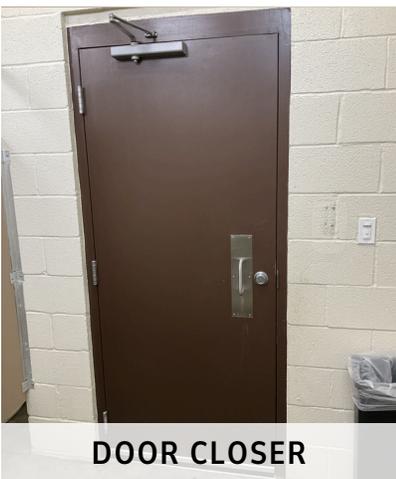
The door is equipped with spring hinges and returns to a closed position too quickly.

Doors and gates with spring hinges shall be adjusted so that from an open position of 70 degrees, the door shall move to the closed position in 1.5 seconds minimum.

Recommendation: Adjust or replace closer/ hinges

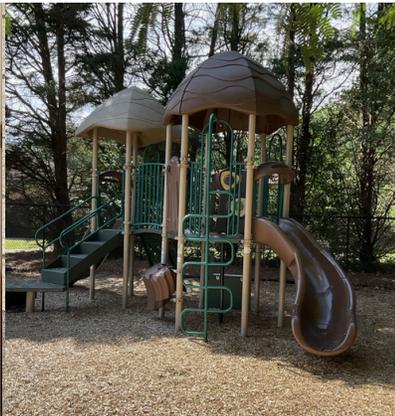
TRANSFER PLATFORM

An accessible route is not provided within the play area or it does not connect accessible ground level components, elevated components, or the entry and exit points of the play components.

Recommendation: Create accessible route to and between components

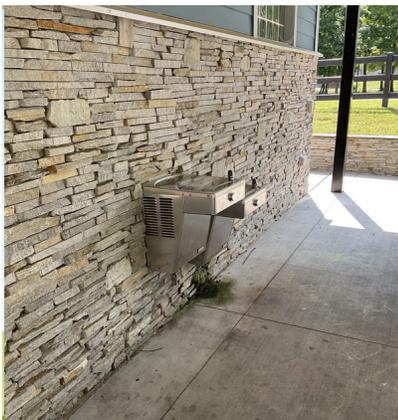
DRINKING FOUNTAINS

The drinking fountain projects from the wall into the pedestrian way with its leading edge above 27 inches from the floor.

Recommendation: Move to a compliant location or provide cane detection

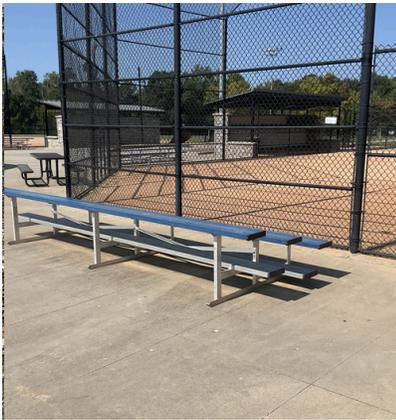
SEATING

Based on the number of seats provided in this area (~22), there should be a minimum of (1) wheelchair seating space at each bleacher.

Recommendation - Provide ADA compliant bleachers
